SPECIAL AIRWORTHINESS INFORMATION BULLETIN

No. CE-00-38
October 17, 2000

- **CRACKS DETECTED ON THE FUSELAGE FRONT BULKHEAD**

MANDATORY BULLETIN **No BE-048/SZD-50-3/2000 „PUCHACZ”**

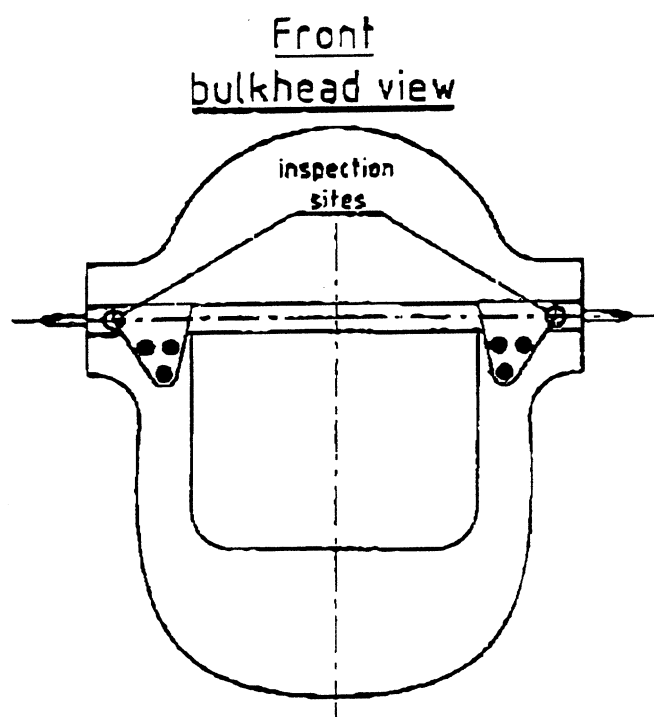
Bulletin Issued due to first information on cracks detected in the front bracket console, mounted on front bulkhead fuselage.

Inspection to be held at sites indicated in the following sketch, both on front and back side of fuselage front bulkhead.

1. Preparatory action at sites specified in a sketch.
 - Wash-out paint from the surface, and de-grease the latter with acetone.
 - Remove impurity from console surface with wire brush.
 - Pre-check the specified sites with aid of magnifying glass of 5x magnification at least.
2. In case of doubts, employ the non-destructive magnetic-flourescent, penetrant-flourescent or penetrant-colour method accepted by Airworthiness Authority.

PDPS "PZL-BIELSKO"	MANDATORY BULLETIN No BE-048/SZD-50-3/2000 "PUCHACZ"	Page: 3 of: 3
<p><u>4. FINAL CONCLUSION</u></p> <p>In cases of finding on a console cracks above 3 mm, this plane should be withdrawn from operation, and producer is to be supplied by fax (No +48 33 812 37 39) with the following information:</p> <ul style="list-style-type: none"> - glider Factory No. - year of production - total flying time - total amount of hour flown in aerobatics - location and size of detected crack. <p>After collecting the necessary information, a Bulletin will be issued - one specifying the repair procedure.</p> <p><u>5. ENCLOSURES</u></p> <p>There are no enclosure to this Bulletin.</p> <p style="text-align: center;">- THE END -</p>
